HAZARD MAPPING FOR INFRASTRUCTURE PLANNING IN THE ARCTIC

ABSTRACT

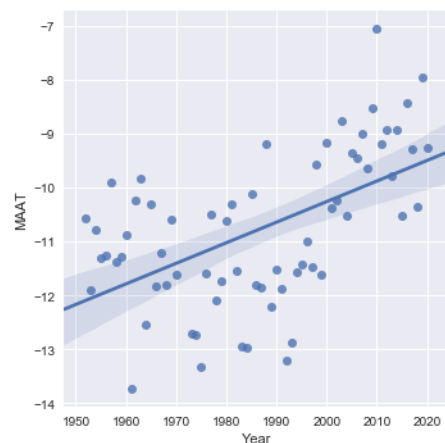
Figure 3. Model Outputs and Line of Best Fit for MAAT

DV	MAAT
IV	Year
Observations	67
R-Squared	0.295
Model	Ordinary Least Squares
Model P-Value	0.00000205
Equation	$MAAT = 0.0382 * (Year) - 86.6$
Coefficient P-Value	0
Intercept P-Value	0

Shown in Figure 3, an analysis of historical weather data indicates that a statistically significant increase in mean annual air temperature (MAAT) has occurred over the last six decades. This is a further indication of the need to examine the risk associated with increased cryogenic action leading to possible facility damage.
